**ENVIRONMENTAL AND MECHANICAL  
SYSTEM ASSESSMENTS  
25 SIGOURNEY STREET, HARTFORD, CT**

**ENVIRONMENTAL AND MECHANICAL  
SYSTEM ASSESSMENTS**

**25 SIGOURNEY STREET, HARTFORD, CT**

**EH&E Report #11767**  
**August 13, 2004**

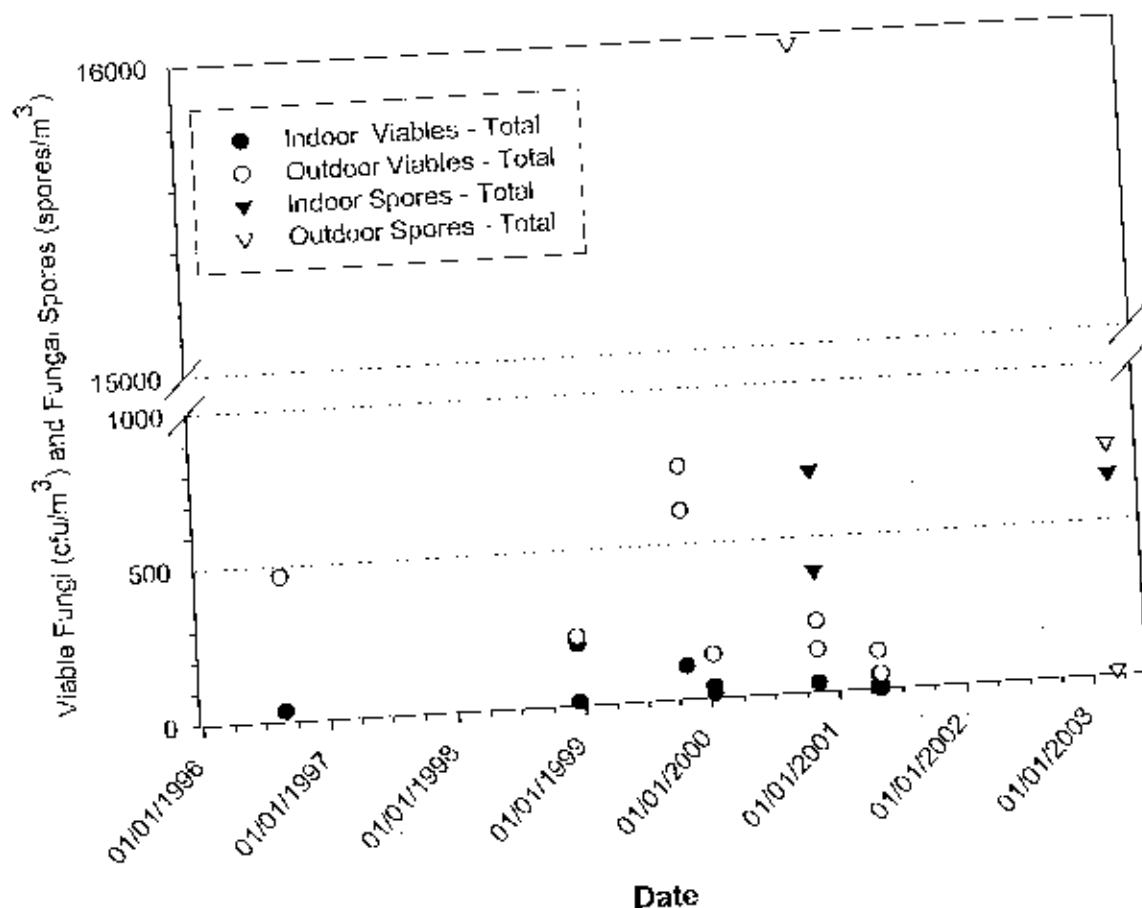
Indoor air concentrations of viable fungi or fungal spores were measured in more than 100 locations distributed over 15 floors of the building between October 1996 and April 2001. On each occasion, at least one corresponding outdoor air sample was also collected. As shown in Figure 2.1, total culturable fungi concentrations in indoor air were less than 200 cfu/m<sup>3</sup> and levels of total fungi indoors were less than those in outdoor air. The types of fungi in the indoor and outdoor air samples were similar, typically *Cladosporium* and basidiospores.

**Figure 2.1** Minimum and Maximum Airborne Fungal Concentrations Measured during Eight Monitoring Periods at 25 Sigourney Street, Hartford, CT

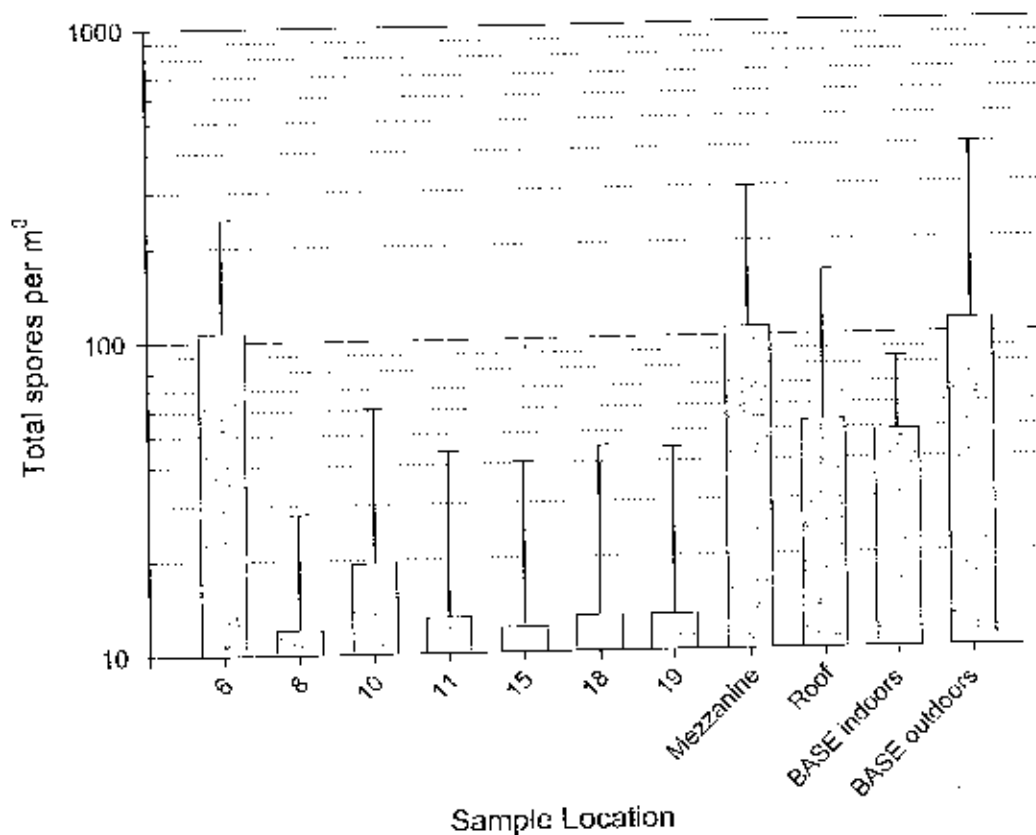
Figure 3.1 Median Total Spore Concentrations by Floor—March 2003

The results indicated that, overall, the indoor spore concentrations on all floors of the building were low and in the range observed in non-complaint buildings. Indoor concentrations were less than 20% of the values for corresponding outdoor

concentrations, except on the sixth floor. Possible reasons for the elevated level on the sixth floor have not yet been determined. The types of spores identified in the indoor samples were the same as those identified in the outdoor samples, which indicated that no unusual sources of fungal growth were present in the indoor environment. The identified spore types primarily included *Penicillium/Aspergillus*, *Cladosporium*, basidiospores, and other small brown types of spores. All of these spore types are commonly found in air samples collected from indoor and outdoor environments. As shown in Figure 3.1, the measured indoor total spore concentrations were similar to levels measured by EH&E for the EPA in its BASE study of buildings located throughout the United States.

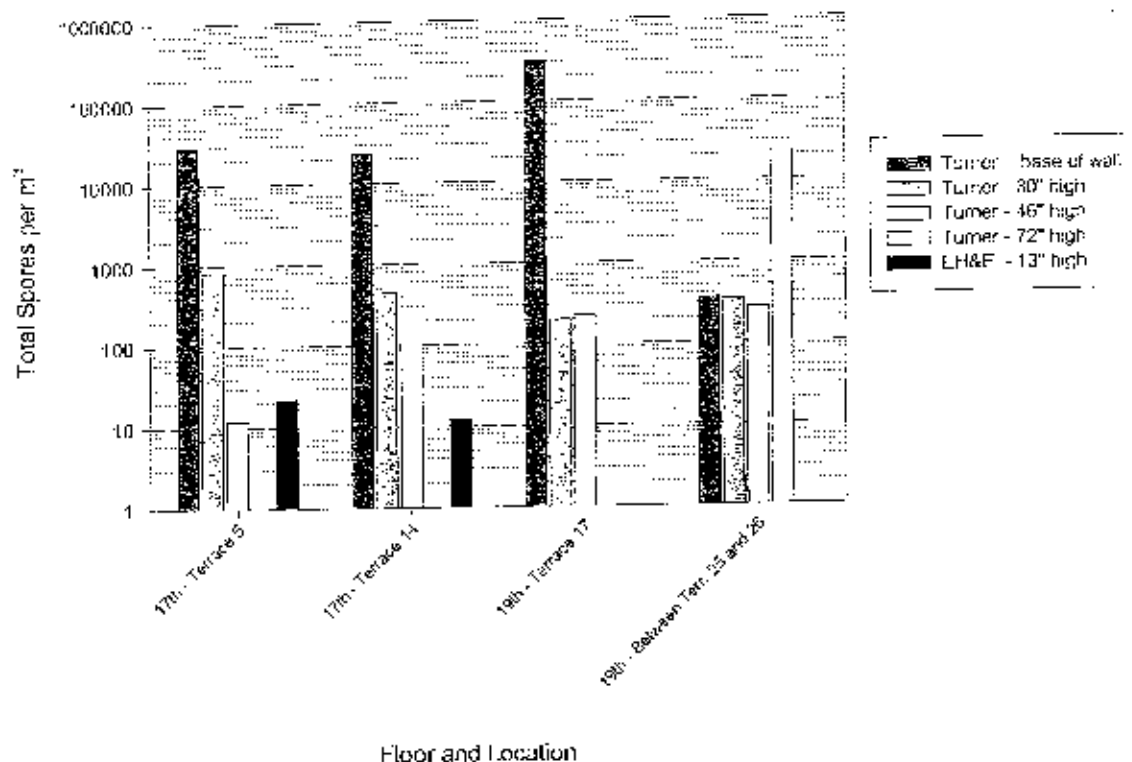
Figure 3.2 presents a summary of data from WallChek<sup>®</sup> samples collected in March 2003 by EH&E following perturbation of the wall. Data presented by the Turner Group from a wall cavity evaluation completed in 2000 are also shown in the chart.<sup>25</sup> The wall cavity samples from the Turner Group were collected adjacent to areas of visible mold growth and were also collected following wall perturbation. The data in this figure are reported as total spores/m<sup>3</sup> of air and plotted on a logarithmic scale.

Figure 3.2 Wall Cavity Samples—March 2000 and July 2002

The Turner Group collected their samples from a series of heights at each sampling location to evaluate the spatial extent of potential fungal growth inside the wall cavity. The results from the report indicated high levels of spores in the wall cavities at their sampling locations on the 17<sup>th</sup> and 19<sup>th</sup> floors; the highest levels were measured at the base of the wall. The Turner Group concluded that the base of the wallboard on the 17<sup>th</sup> and 19<sup>th</sup> floors was supporting mold growth. Following this report, the wallboard along an entire exterior wall on the 17<sup>th</sup> floor was removed and replaced. This replacement may account for the much lower levels of spores measured on the 17<sup>th</sup> floor by EH&E in March 2003. Based on a joint decision with the DPW and NIOSH, EH&E did not collect wall cavity samples on the 19<sup>th</sup> floor because the walls had recently been abated and replaced.

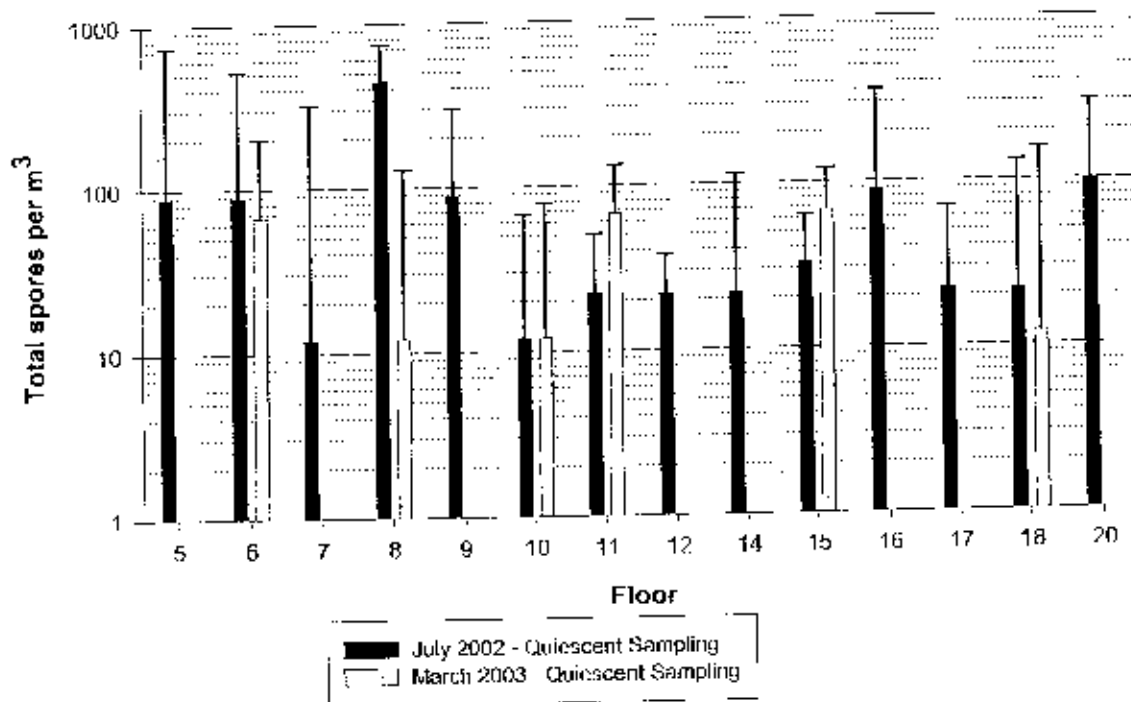
**Figure 3.3** Wall Cavity Sampling—July 2002 and March 2003

One objective for comparison of these data was to determine whether conditions had changed in the wall cavities between the July 2002 and March 2003 sampling periods. The results indicated no statistically significant differences in the results between the two sampling periods. This suggests that conditions in the wall cavities related to possible reservoirs of fungal growth had not changed substantially between the two time periods.

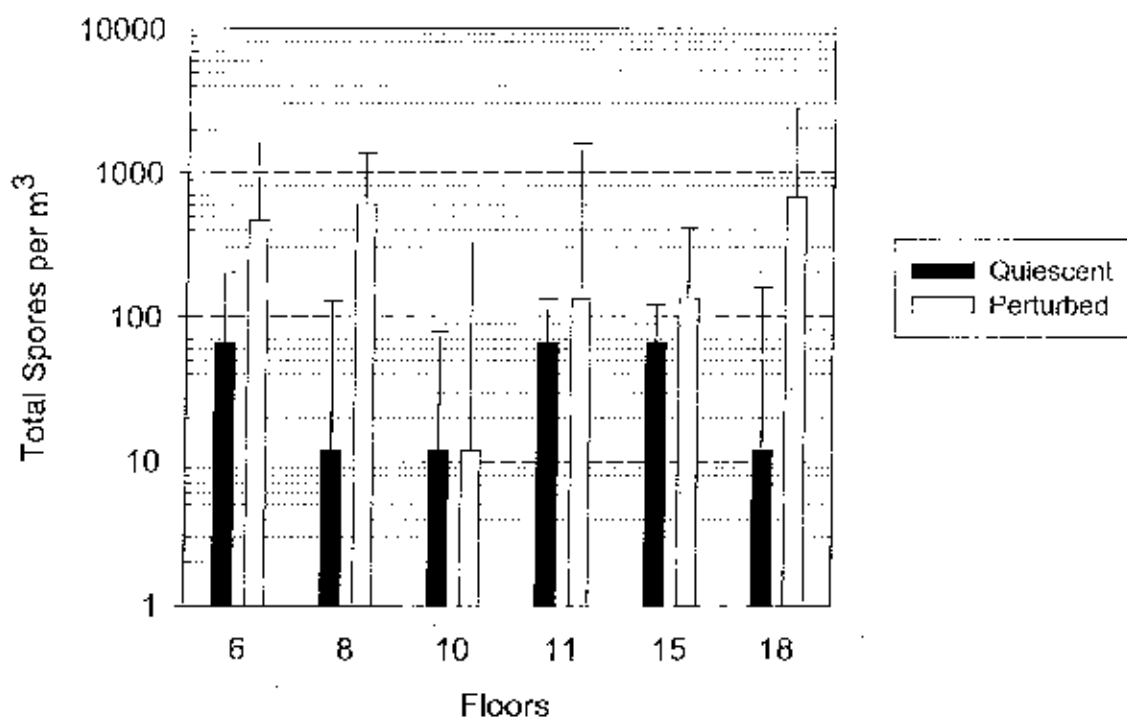
**Figure 3.4** Wall Cavity Sampling—March 2003 Perturbed and Quiescent

Qualitatively, sampling of the wall cavities following perturbation yielded higher total spore concentrations than quiescent sampling. EH&E is in the process of conducting a careful quantitative analysis of the data to support interpretation of these results.
